AFFIDAVIT OF WILLIAM W. VAN ARSDELL, PH.D.

Re: Kashper v. Toyota

On January 26, 2017, Mr. Konstantin Kashper was the driver and sole occupant of a 2016 Toyota Tacoma traveling on I-495. His vehicle reportedly went off of the side of the roadway and subsequently rolled over. The vehicle was found on its roof at point of rest. Mr. Kashper sustained fatal injuries.

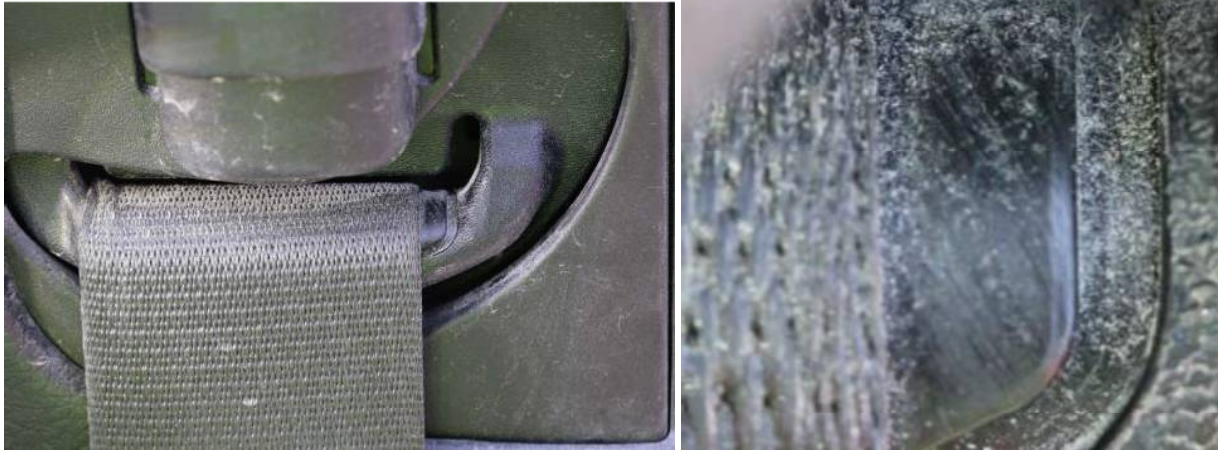
Figure 2a: Driver D-ring

deployed, with the retractor locked and jammed, so that the webbing is pulled tight against the door and will not extract or retract. There are marks consistent with pretensioner deployment on the D-ring. There are no occupant load marks visible on the webbing, D-ring or latch-plate. There is a deposit on the webbing where the latch plate has settled above the stop button.

The fact that the seat belt is stowed, locked and jammed as well as the marks on the webbing, D-ring and latch plate show that Mr. Kashper was not wearing his seat belt at the onset of the crash. The literature contains numerous examples of how engineering analysis of seat belt marks can be used to reliably determine if and how a seat belt was worn and how the seat belt performed in a collision.^{25,26,27,28,29,30,31,32,33,34,35,36,37,38,39,40} I have published a peer-reviewed

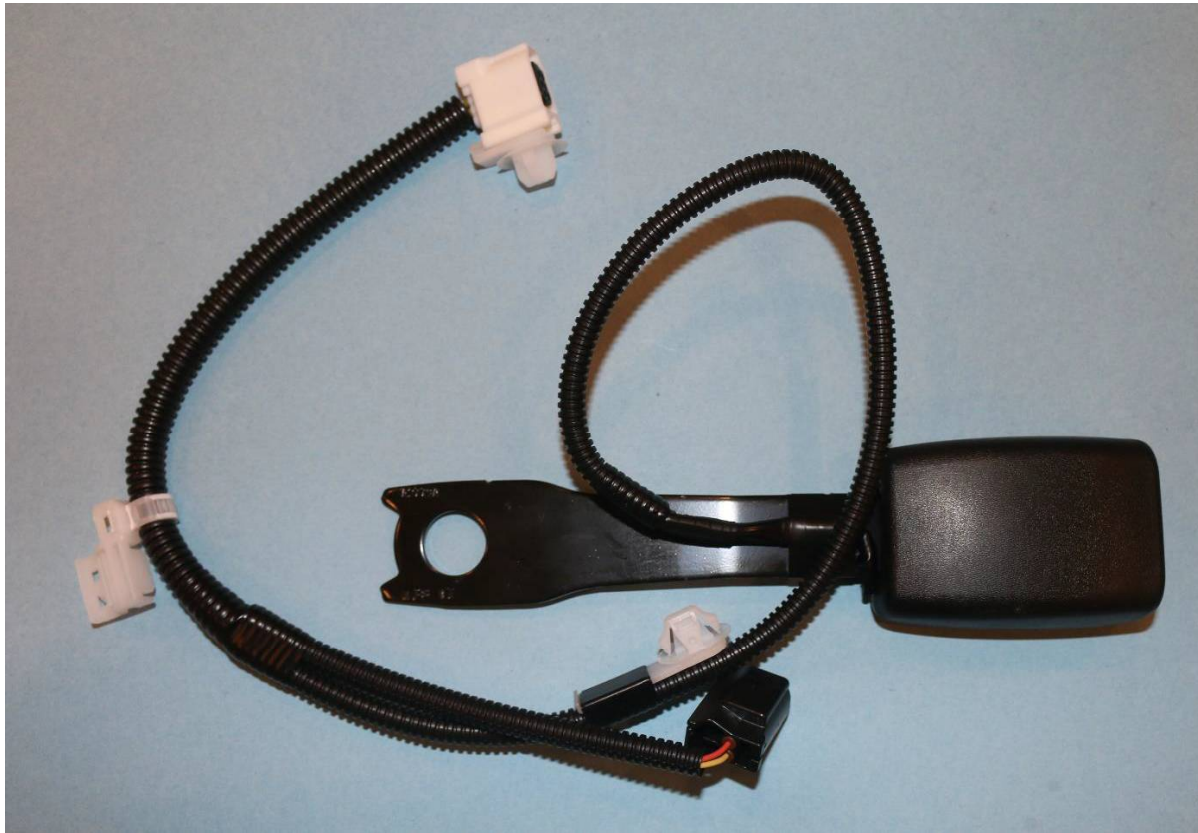
Figure 3: Photographs – 2016 Toyota Tacoma service replacement buckle, mechanism

The subject buckle design is inherently resistant to partial engagement. I have thoroughly examined an exemplar service replacement buckle to analyze both the latching/unlatching mechanism and the buckle switch function, including disassembling this exemplar buckle (Figure 3). The buckle switch is a non-contact switch. Although it is clear that the subject buckle, and this buckle design in general are *not* prone to partial engagement, if somehow a partial engagement condition was achieved, this switch and buckle design would not indicate a status of unbuckled to the vehicle diagnostics even in this hypothetical partially engaged condition. The fact that the EDR indicates that the buckle was unbuckled at the time of the crash clearly indicates that the buckle was *neither* fully latched *nor* partially engaged at the time of the subject collision and rollover sequence.

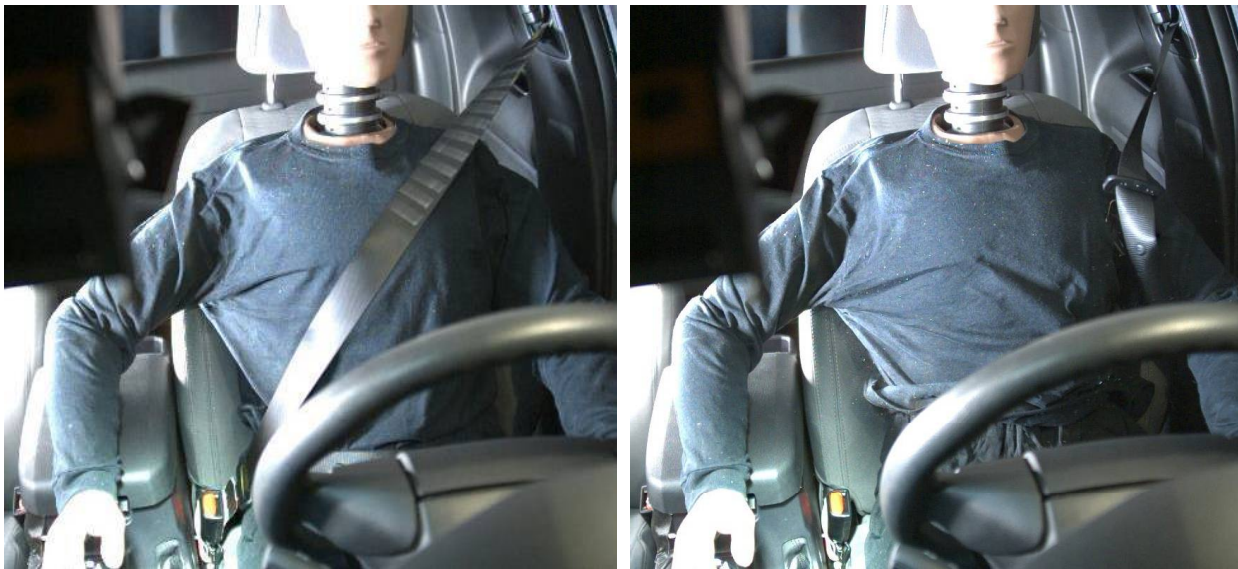
Figure 6: Still frame images from pretensioner deployment with taped latch-plate buckle

On August 23, 2018, at DRE, I conducted two pretensioner deployments.¹⁰ In the first deployment, a 50th percentile HIII anthropometric test device (ATD) was seated in an exemplar Toyota Tacoma, with its left hand on the steering wheel. The right arm was placed on the arm rest to allow for a clear view of the buckle. The seat belt was properly routed over the ATD's torso and lap/pelvis. The latch-plate was taped to the buckle cover to simulate a buckle that was somehow in a condition of partial engagement ("false latched"). The pretensioner was deployed. The event was recorded with both high-speed and real-time video. When the pretensioner was deployed, the webbing was partially retracted but did not return to the stowed position (Figure 6). At the end of the demonstration, the seat belt was partially extended and was still draped around the ATD's left arm. The retractor was not jammed (i.e. webbing would still retract). This *is not consistent* with the condition in which Mr. Kashper's seat belt was found. Mr. Kashper's seat belt was found fully stowed and pulled tight against the interior trim of the vehicle with a locked and jammed retractor.

Pre deployment of pretensioner

Post deployment of pretensioner

After replacing the seat belt with a new service replacement seat belt, a second demonstration was conducted. I deployed the driver pretensioner with the belt in the stowed position. In this second demonstration, the seat belt was pulled tight against the interior trim of the vehicle and retractor was locked and jammed. This *is consistent* with the condition of Mr. Kashper's seat belt at the end of his collision and rollover sequence and further proves that Mr. Kashper was not wearing his seat belt at the time of this crash. (The high-speed video for each of these tests is in my file).

As discussed elsewhere in this report, the fact that Mr. Kashper's seat belt was found locked and jammed with the webbing tight against the interior trim of the vehicle in a stowed condition clearly shows that Mr. Kashper was not wearing his seat belt when the pretensioner deployed in the subject crash.

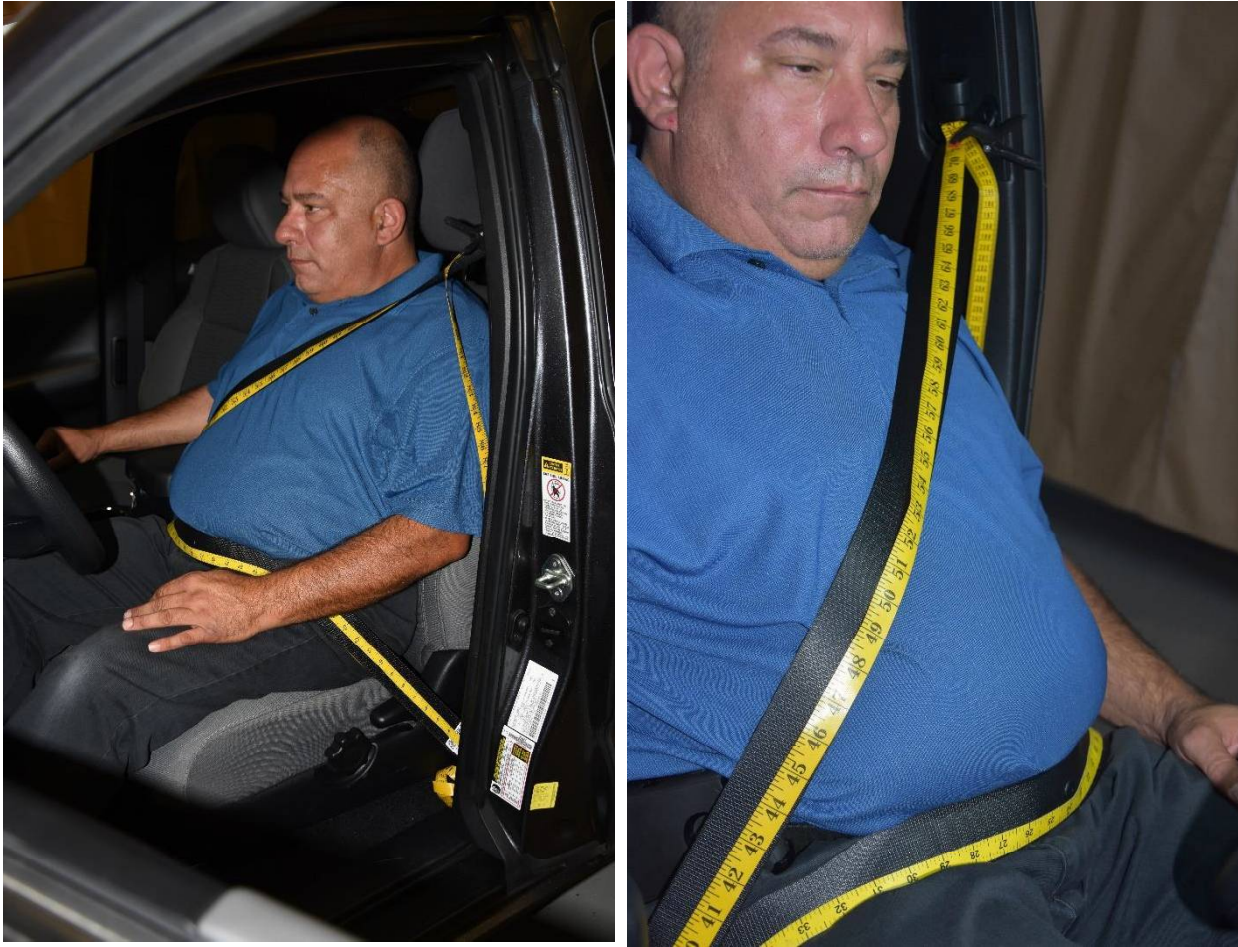
Figure 7: Surrogate Photographs

The surrogate was properly positioned in the driver seat and restrained with a properly positioned and snug seat belt (Figure 7). When properly positioned and buckled, the Toyota Tacoma seat belt provides good fit for an occupant the size of Mr. Kashper.
